INSPECTION FACT SHEET

COMPANY NAME Rock Springs Enterprises ID # Non Handler
MAILING ADDRESS PO Box 95 TYPE OF FACILITY Non Handler
Chester WV 26034
LOCATION Eighth Street COUNTY Hancock
Chester WV
COMPANY CONTACT Robert Deitz HANDLING CODES None
PHONE (304) 387 41 8

PURPOSE Citizen s Complaint

TRIP REPORT

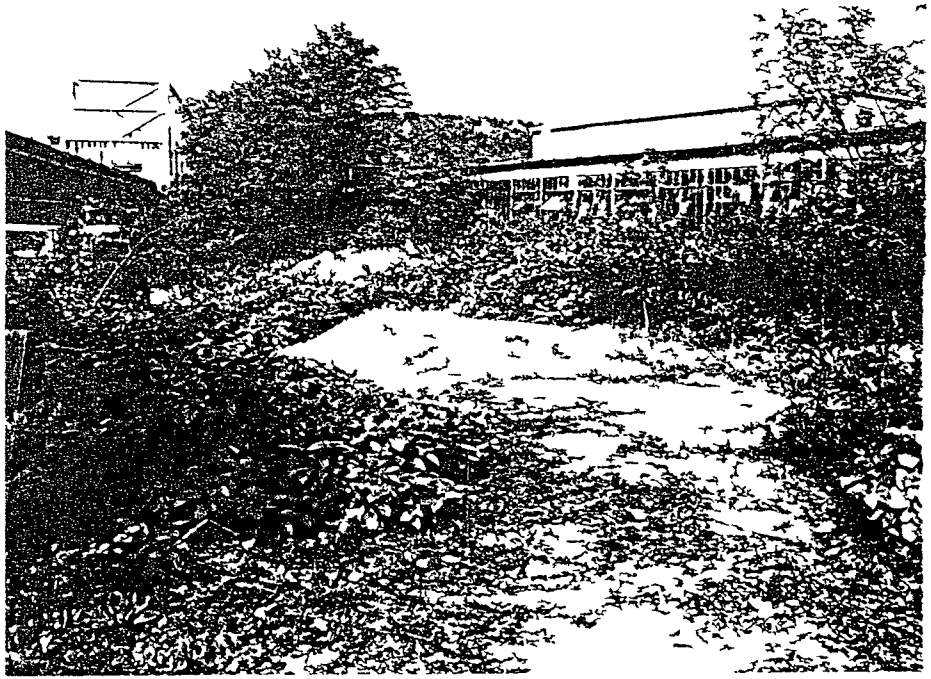
Photo #	Time	Lighting Condition	Description
1	13 07	Sunny	View of waste pile from east looking toward the west. Sample number 2 was collected from the top of the pile in the center of the photo. The building in the right of the photo is the main building noted in the text. The road and bridge are part of US Route 30.
2	13 08	Sunny	View of waste pile looking south. Sample number 1 was collected from the clearing in the center of the photo. The bridge in the background is part of US Route 30.
3	13 15	Low Light	View inside the kiln where sample number three was collected. Inside height of kiln is approximately eight feet.
4	13 16	Low Light	Overview showing entrance of kiln from photo number 3.
5	13 28	Low Light	View of passage under kiln. Location where sample number 4 was collected.
6	13 30	Low Light	Overview showing area around passageway in photo number 5.
